RESEARCH MEMORANDUM

FACILITIES AND METHODS USED IN FULL-SCALE
AIRPLANE CRASH-FIRE INVESTIGATION

By Dugald O. Black

Lewis Flight Propulsion Laboratory
Cleveland, Ohio

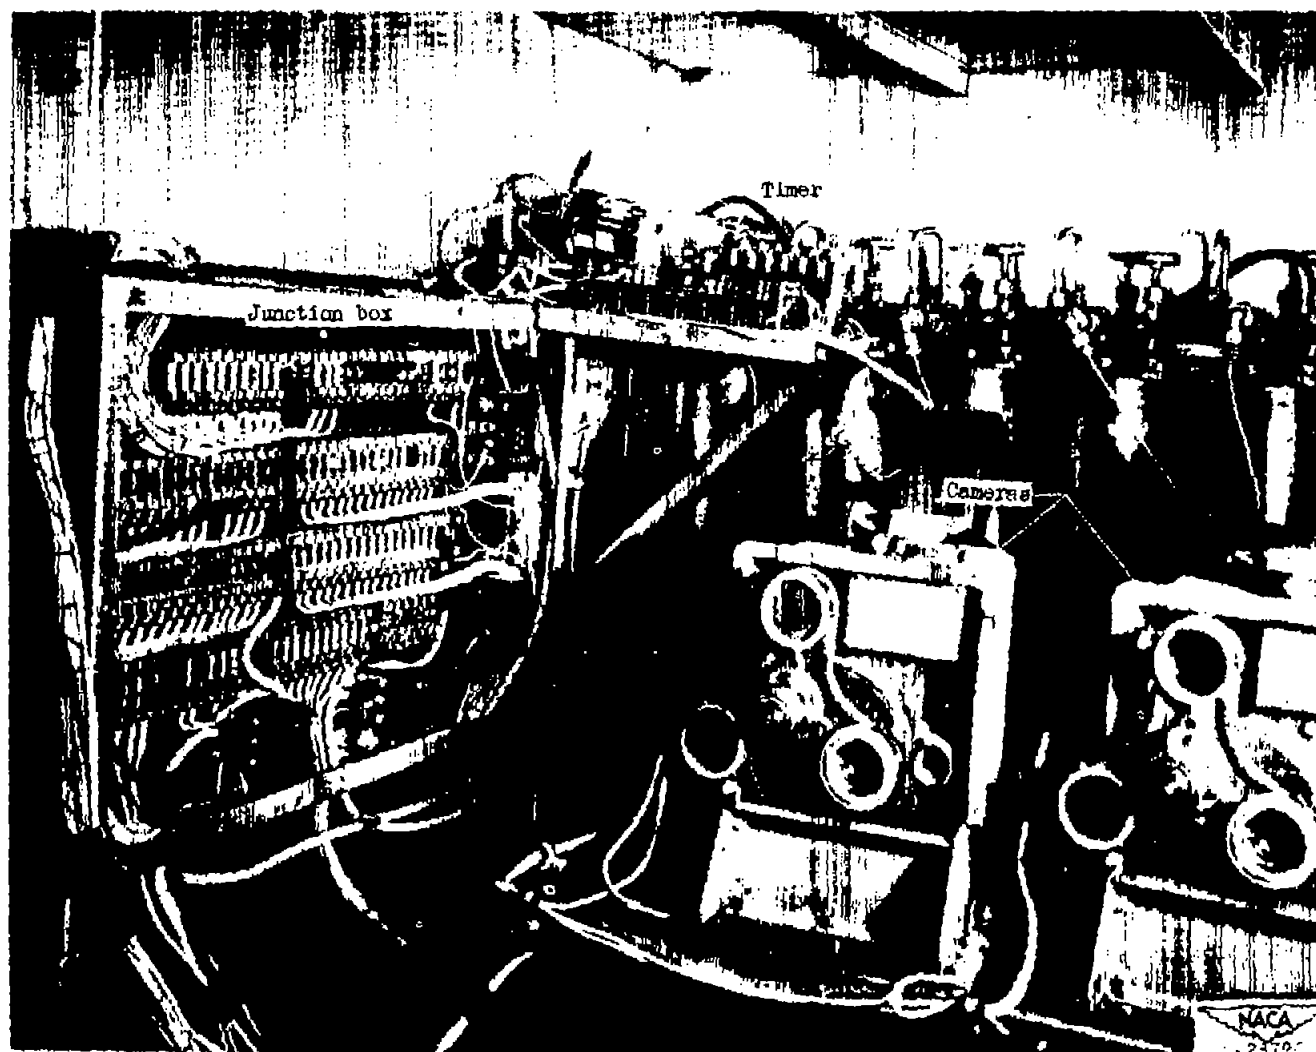
Figure 24. - Closeup view of installation of cameras, junction box, and timer in fireproof instrument box.

Fireproof instrument box. - It was necessary that the temperature inside the instrument box remain below 200° F in order to protect the motion-picture film in the cameras. A sketch of the fireproof instrument box showing the general dimensions and type of construction is presented in figure 20. The inside dimensions were: length, 8 feet; width, 5 feet; and height, 4 feet. The box was constructed of three 1/16-inch-thick black-iron boxes nested together with 3 inches of insulation between the inner and center boxes; 3 inches of water between the center and outer box walls with 1 inch and 5 inches of water on the bottom and the top, respectively. The inner box was shock mounted to the center box by rubber mounts to help absorb the shock of the crash. Figure 21 shows the construction of the instrument box before the top was installed. This view shows the space for insulation, water jacket, and rubber mounts. The instrument panel was mounted at one end of the box as shown in figure 22. Batteries for power, potentiometer, cameras, junction box, cabin-air sampling containers, and timer were located at the opposite end of the box as shown in figure 23; figure 24 is a close-up view showing the installation of the cameras, junction box, and timer for cabin-air sampling system.

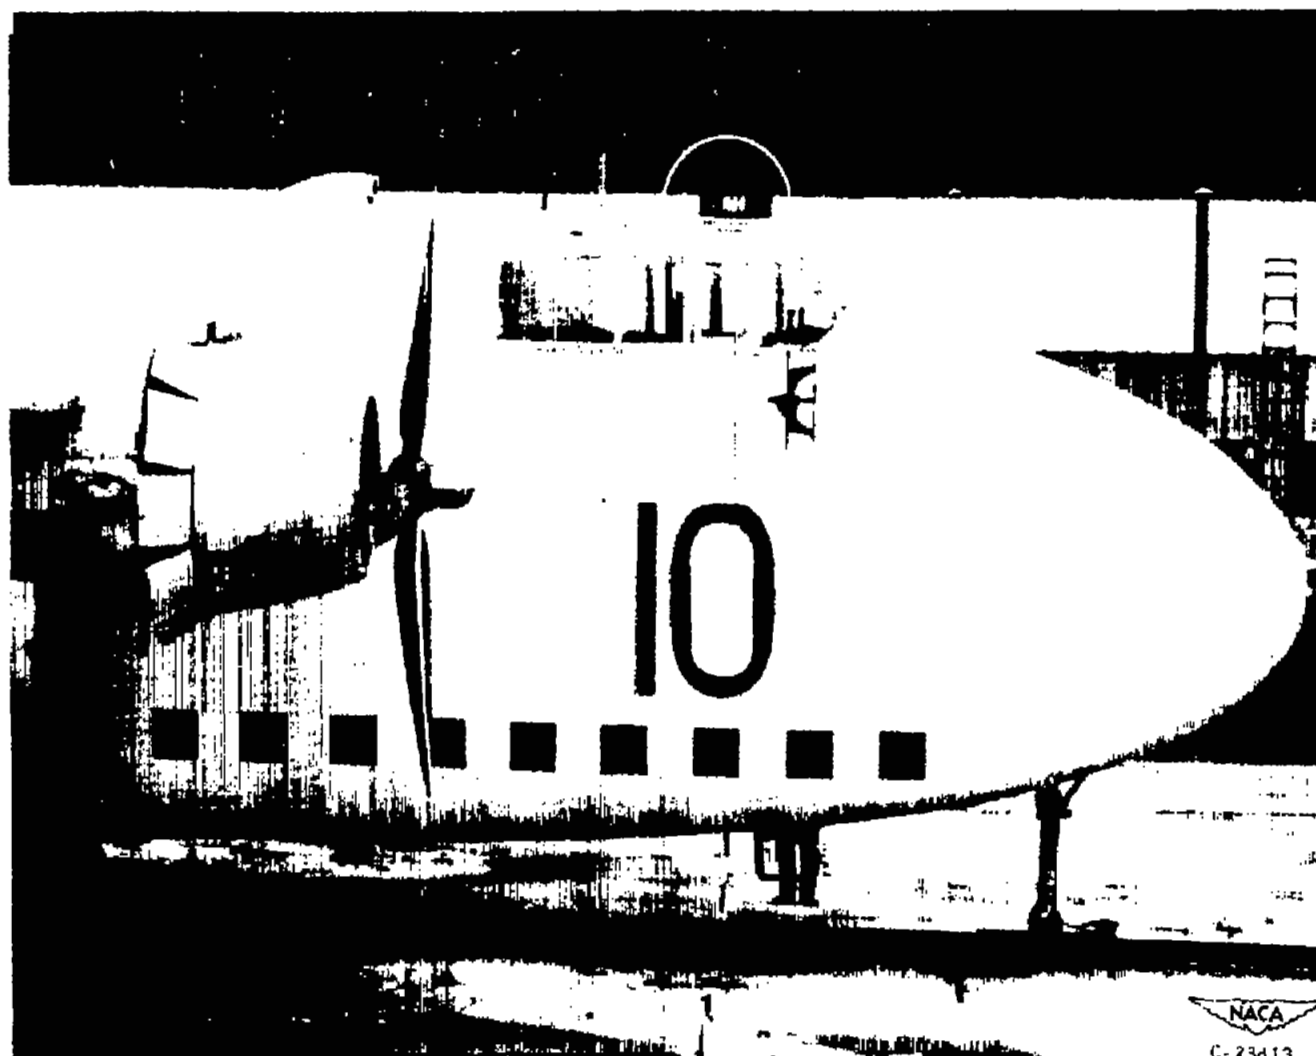
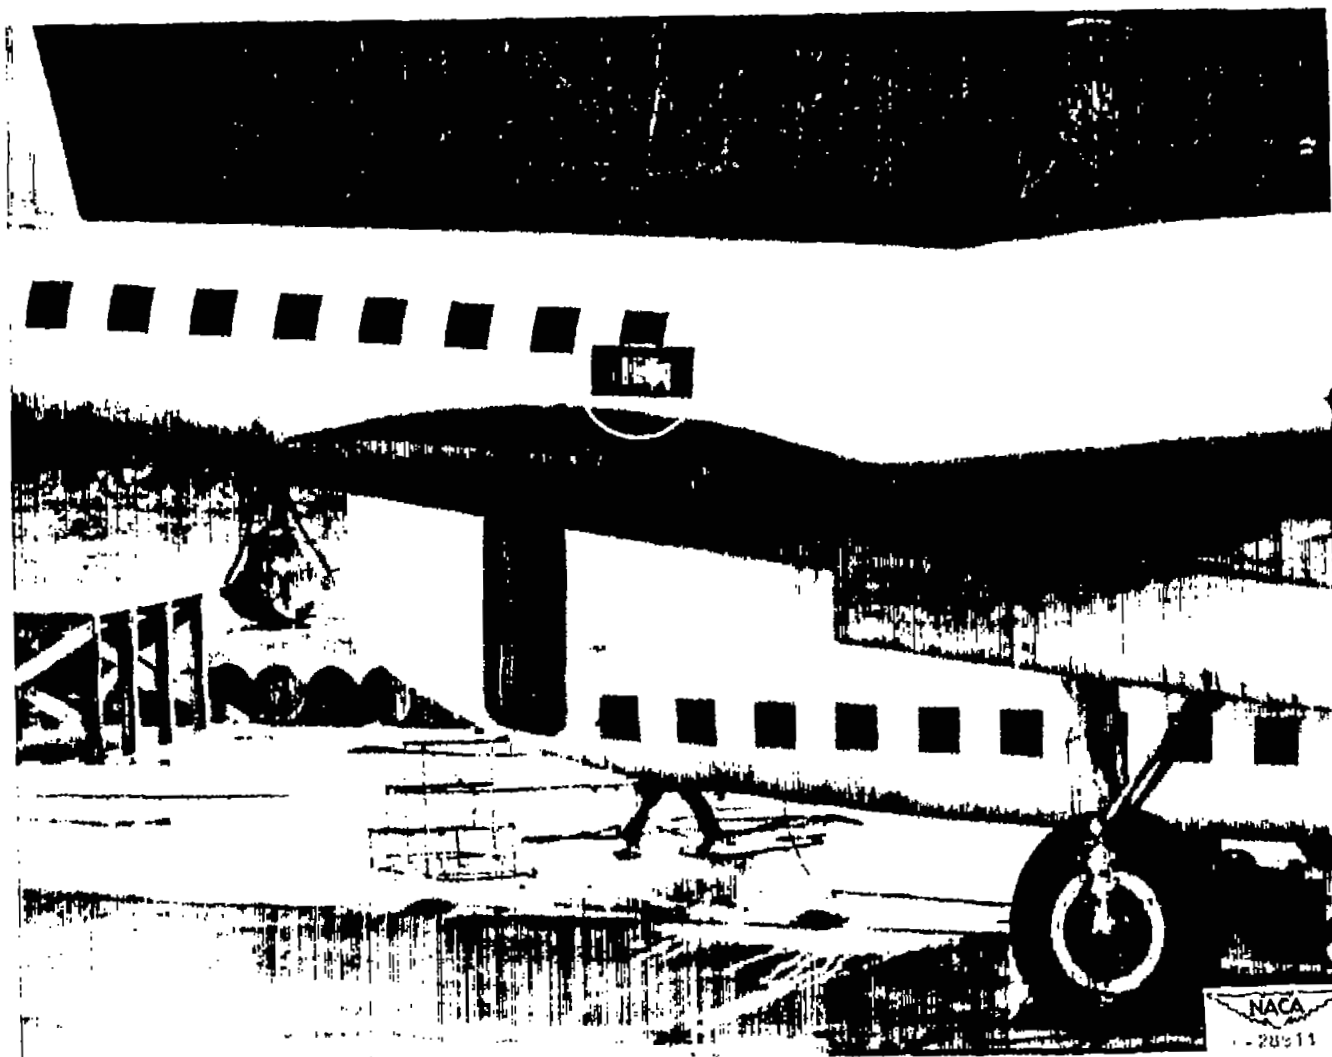
(a) On top of fuselage.

Figure 28. - Timing lights installed on C-82 airplane.

(b) On right wing tip.

(c) On right vertical wing tip.

The lights were so located on the airplane that each of the cameras around the crash area would photograph at least one set of lights regardless of the position of the airplane in the crash area. One set of lights was installed on top of the fuselage above the cockpit as shown in figure 28(a); one set was installed on each wing tip as shown in figure 28(b); and another set was installed on the outboard side of each vertical stabilizer (fig. 28(c)). All the lights were connected to a clock-timer mechanism located in the insulated instrument box. This timer also controlled an indicating light so installed on the instrument panel in the fireproof instrument box that synchronization of the external light with the instrument panel light was obtained. In this way, the panel instrument readings could be related to the motion-picture records obtained by the cameras stationed around the crash area.

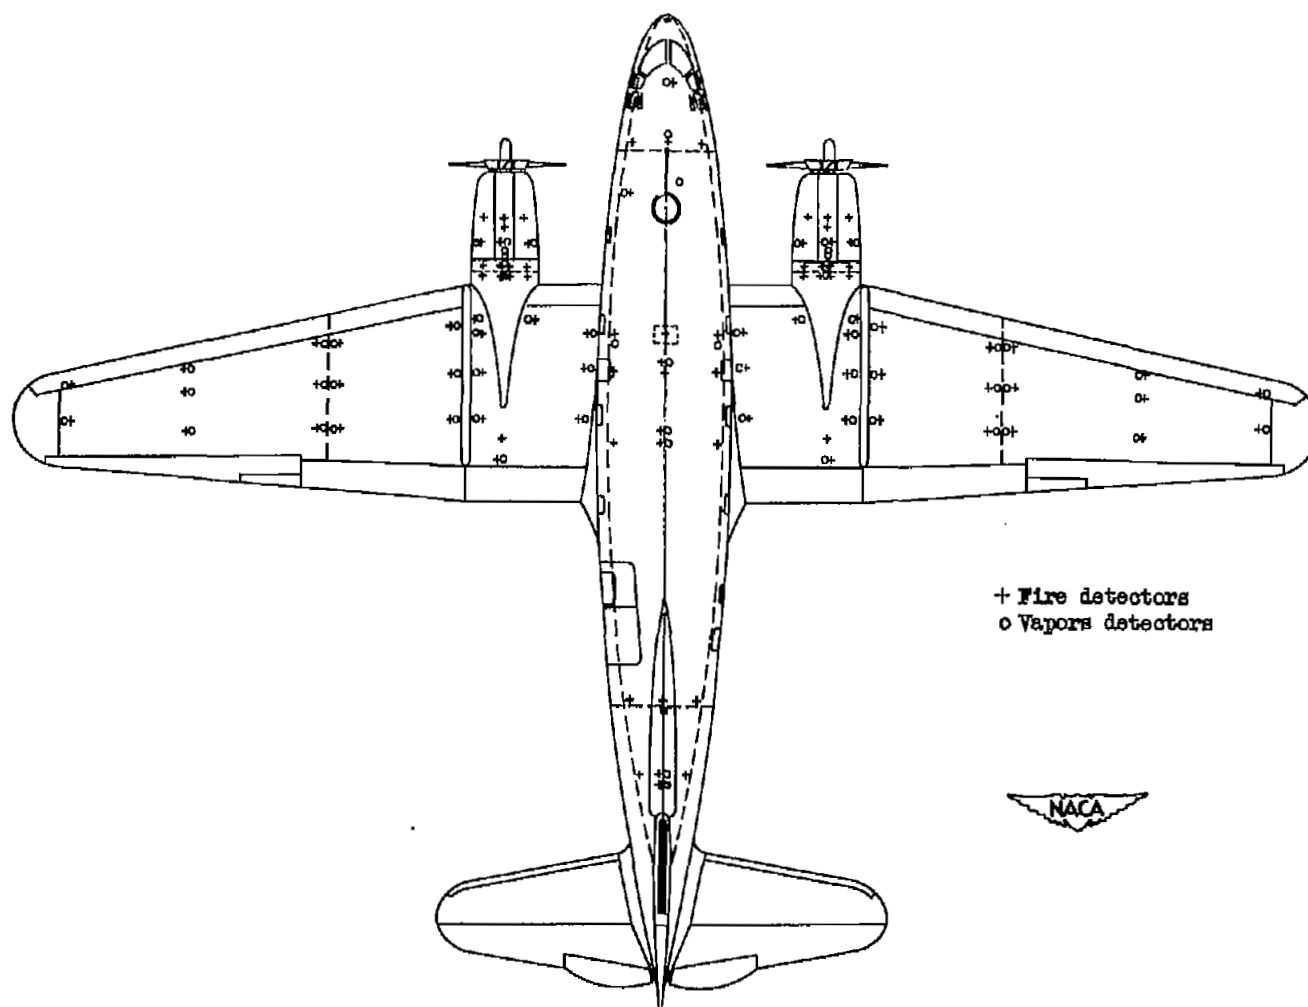
Figure 29. - Location of fire and vapor detectors installed in C-46 airplanes.

Fire detectors. - Thermocouples were used to detect the origin and spread of flame throughout the aircraft structure. A typical thermocouple installation of a completely instrumented airplane is shown schematically in figure 29; coverage of the nacelles, wings, and fuselage was obtained by use of 102 thermocouples. The greatest number of thermocouples were located in the nacelles near the exhaust-disposal system where the fire was likely to originate. Each thermocouple was connected to a meter on the instrument-box panel.

The locations of the vapor detectors (fig. 29) were chosen as the most likely paths that combustible vapors may follow throughout the structure of the aircraft. Each detector consisted of a 24-volt army-type C-1 booster coil sealed in a black iron body, a copper mesh screen, and two thermocouples. The booster coil supplied a spark which was totally enclosed in the copper screen that acted as a Davy safety shield. As a combustible vapor passes through this screen and comes in contact with the spark, burning occurs inside the screen. A thermocouple installed inside the screen was used to indicate when ignition of the combustible mixture within the screen occurred. An additional thermocouple, located outside the screen, was connected in series with the thermocouple inside the screen and indicated passage of a flame front. With this arrangement, a positive reading would indicate a combustible vapor; a negative reading, fire; and an ambient-temperature rise would not change the reading.

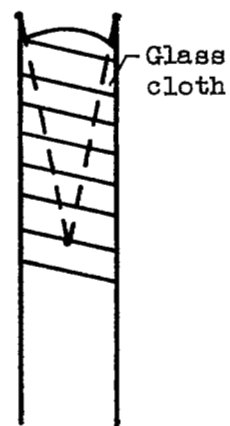
(b) Wrapped.

Figure 30. - Construction of thermopiles.

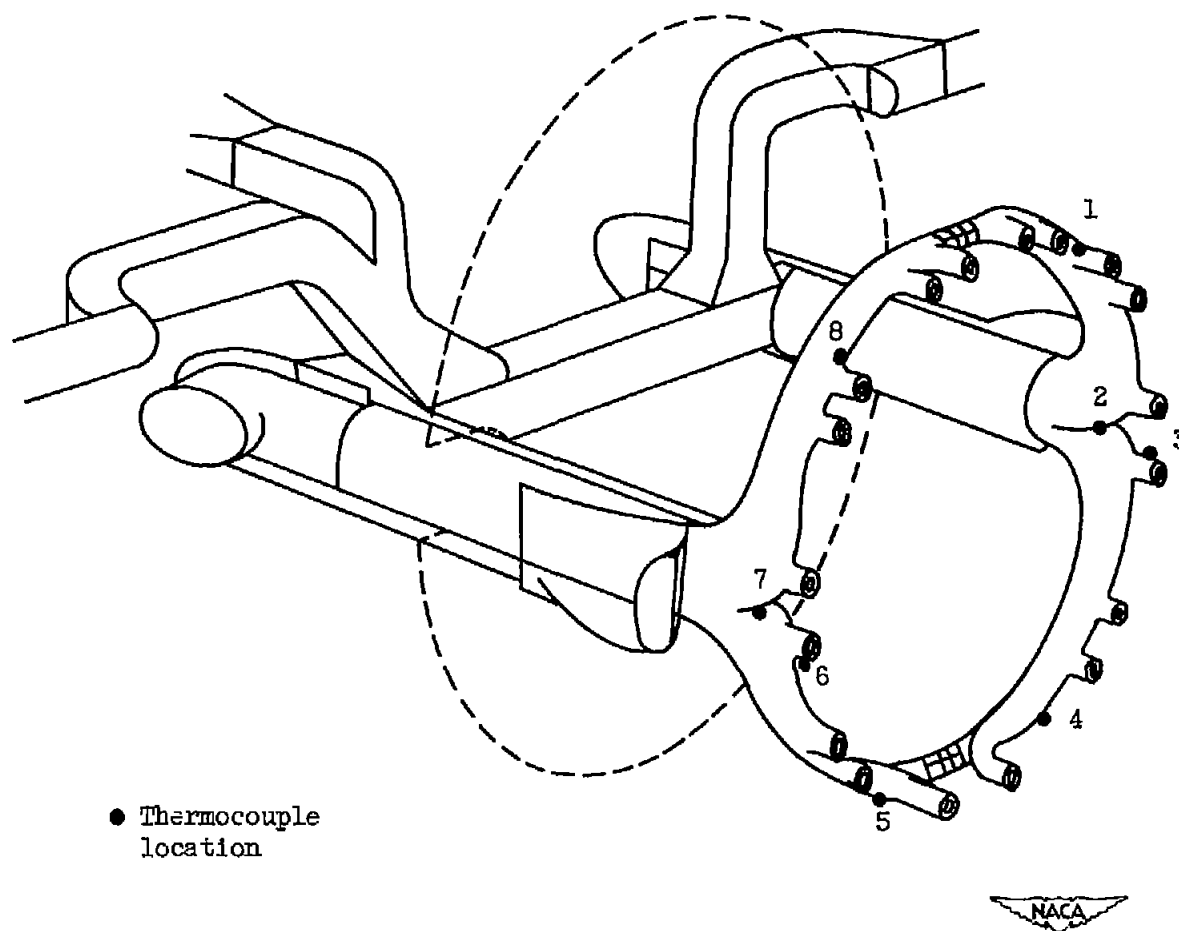
Figure 34. - Left-engine exhaust-stack thermocouple locations on C-82 airplane.

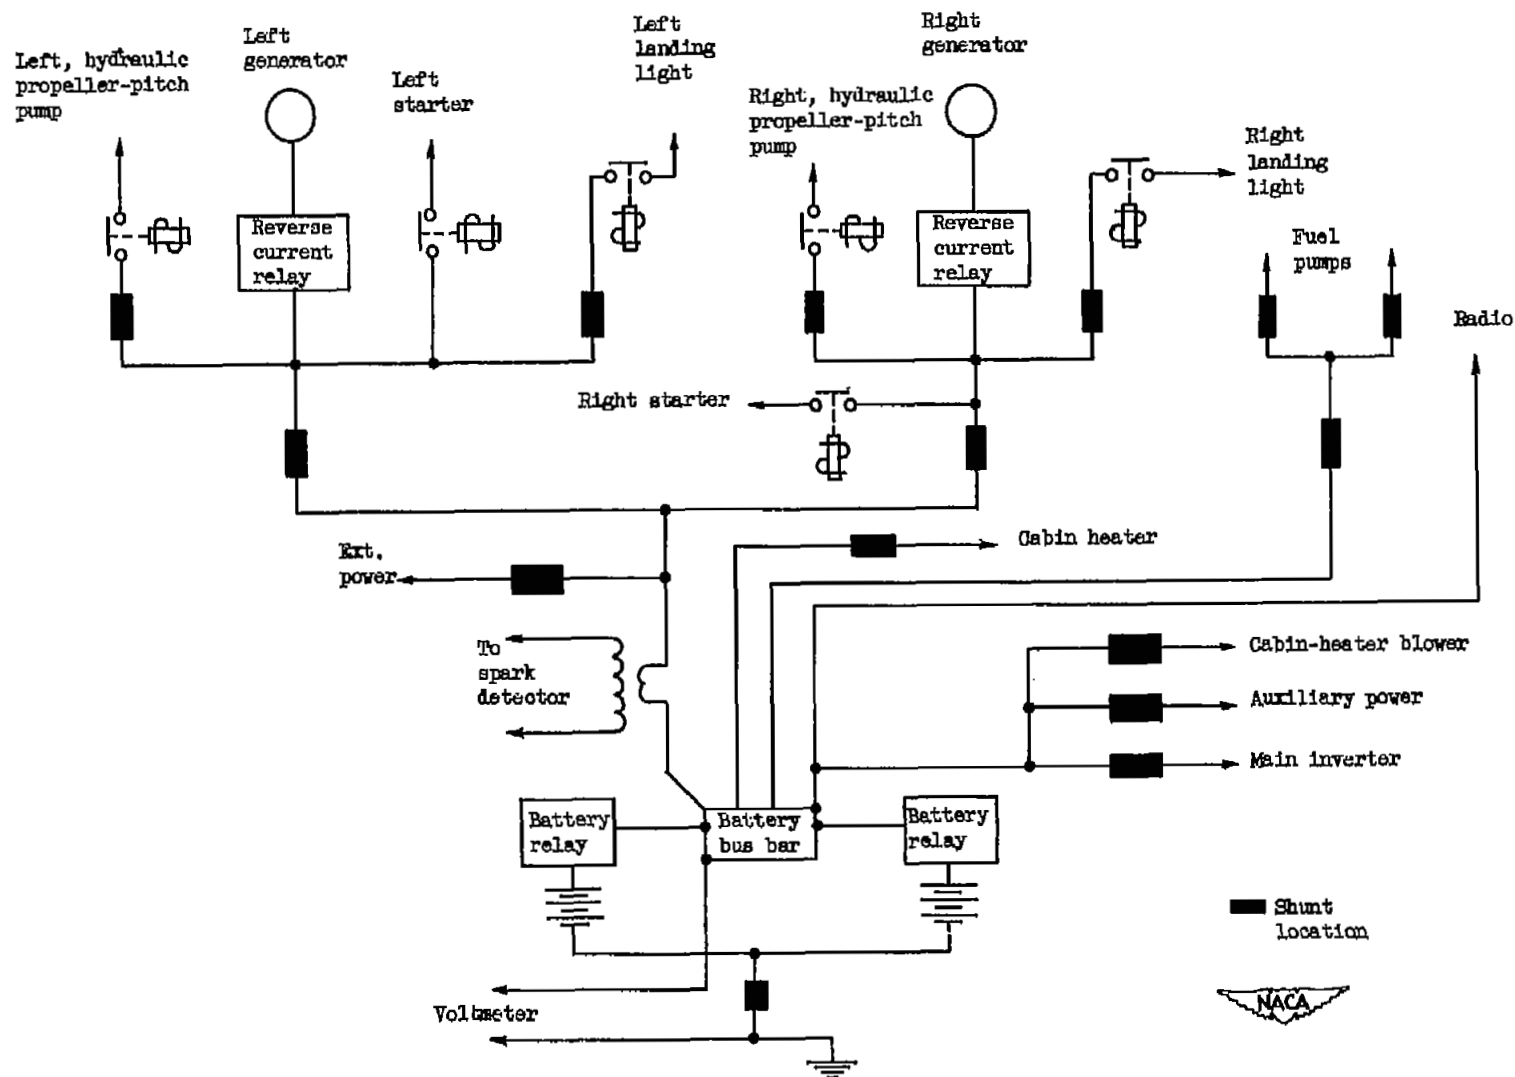
Figure 35. - Shunt locations in electric system of C-16 airplane for third crash.

Detection of electric-system failures. - In order to detect electric-system failures that could provide ignition sources, shunted ammeters were installed in the electric system of the test airplanes. All ammeters registered from 0 to 300 amperes. Shunts used in this installation provided a 50-millivolt voltage drop, which corresponded to a short circuit when 300-amperes flowed. These shunts were placed in the electric lines at various locations throughout the airplane (fig. 35) and connected to ammeters installed on the panel in the instrument box by asbestos covered number 14-gage solid-nickel wire. Abnormally high currents caused by arcing of a broken power line were measured by the shunts and the ammeters.

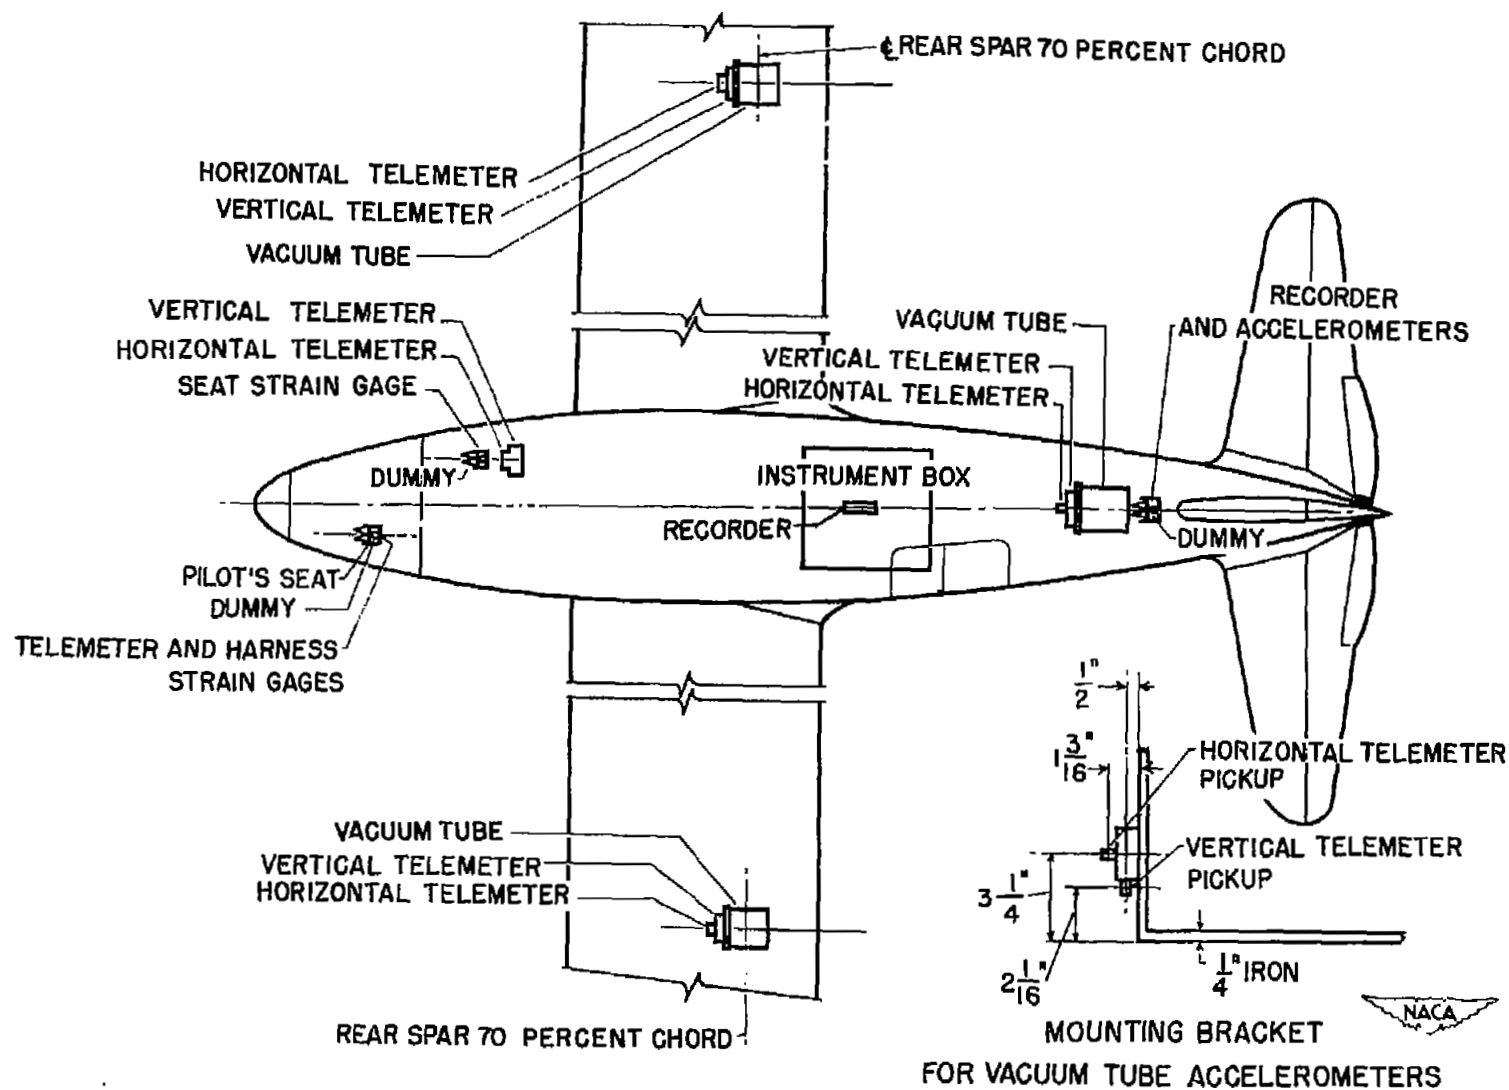
Figure 36. - Recorder, accelerometer-pickup, and strain-gage locations in C-46 airplane.

Variable-inductance accelerometer-pickups that recorded through a telemetering system were installed in the aircraft because investigations at the NACA Langley laboratory have indicated that this system was one having low zero shift and high accuracy. Two telemetering transmitters, operating on 134 and 150 megacycle frequencies, were installed on the passenger compartment floor forward of the instrument box. The transmitting antennas were mounted at about 45° angles on the sides of the fuselage 2 feet below the top. Two pickups for measuring structural accelerations were installed in each of four locations in the aircraft as shown in figure 36. These pickups were mounted on angle brackets and aligned in the horizontal and vertical planes with the aircraft in flight attitude. Two pickups were mounted on brackets on the left- and right-wing lifting attachment points for rigidity (fig. 36). These pickups indicated wing accelerations, which could be correlated with accelerations determined with the vacuum tubes. The other two pair were located close to the dummies in the fuselage of the aircraft (fig. 36) so that harness strain-gage data could be related to the telemetered accelerometer data.

from 0.015-0.010-inch diameter. This vacuum tube, used as a transducer, was a dual diode tube which is essentially a pair of rectifiers connected in series and having a common cathode. As accelerating forces acted on the tube, the plates moved a distance proportional to the acceleration force. One plate moved toward the cathode and the other away from it thus the effective resistance of one-half of the tube increased and the other decreased as acceleration was applied. This tube was so connected that the two halves were two adjacent legs of a Wheatstone bridge. The electric output was applied directly to a rotating-mirror-type recording galvanometer. The data were obtained on photographic film. The tubes were located in the fuselage and wings of the airplane as shown in figure 36. The boxes in which the pickup tubes were mounted were made of 1/32-inch steel and secured with 1/16-inch by 1/2-inch steel straps to the bracket shown in figure 36.

In the third system, unbonded strain-gage accelerometers were used in conjunction with two 6-channel pilot-seat-ejection recorders. The unbonded strain-gage accelerometers consisted of a thin metal cantilever beam attached to an aluminum frame which was bolted to the point at which accelerations were to be measured. Attached to this cantilever were insulated posts between which thin resistance wires were stretched. As an accelerating force was applied to the system the cantilever beam bent and the wires on one side were stretched, whereas those on the other side were relaxed. Resistance increased in the stretched wire and decreased in the relaxed wire. Both changes were proportional to the amount of bending in the cantilever beam which was proportional to the accelerating force. The wires were connected in a bridge circuit and energized by a constant voltage from the pilot-seat-ejection recorder. The bridge output voltage was proportional to the bridge unbalance voltage which was proportional to the resistance changes previously mentioned. Thus, a voltage proportional to the accelerating force was obtained. The bridge unbalance voltage was detected and used to shift the frequency of a 3500-cycle-per-second oscillator the output of which was recorded on magnetic iron-oxide-coated paper tape. The locations of the recorders and accelerometers are shown in figure 36.

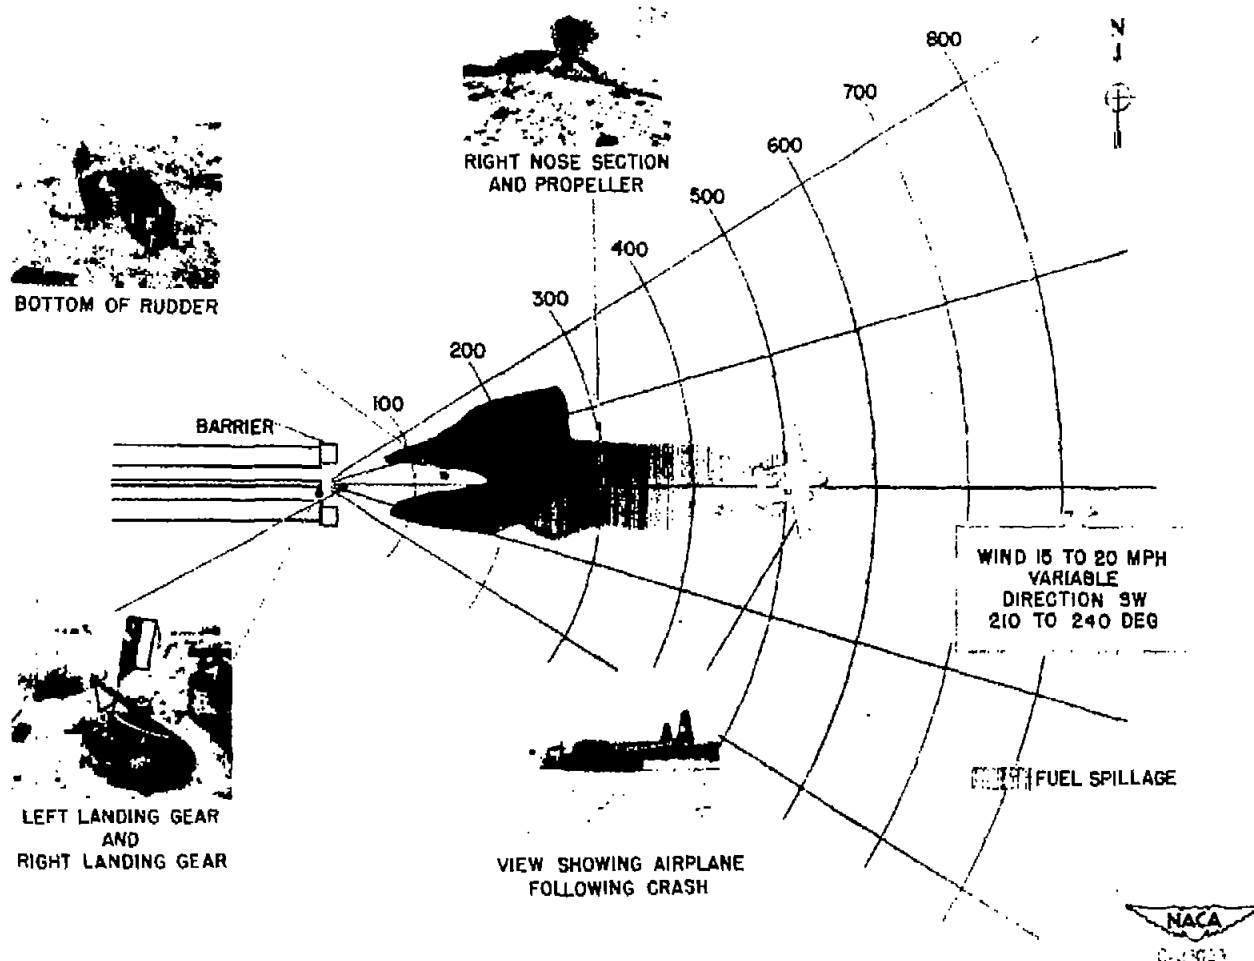
Figure 40. - Distribution of wreckage of C-82 airplane following simulated take-off accident. Test No. Y-4.

The distribution of wreckage was plotted with a plane table and alidade. The following portions of the airplane wreckage and the terrain were identified, recorded, and photographed such as: (1) main landing gear, (2) engine and propellers, (3) sections of the wings, and (4) sliding path, location, and burned-out portion of the airplane. The information obtained by plotting and photographing the distribution of wreckage was transferred to a composite photograph an example of which is shown in figure 40.
